NAVAL POSTGRADUATE SCHOOL

COMBAT DAMAGE ASSESSMENT TEAM
A-10/GAU-8 LOW ANGLE FIRINGS
VERSUS
SIMULATED SOVIET TANK COMPANY
(15 June 1978)

August 1979

Prepared for: A-10 System Program Office
Wright Patterson Air Force Base
Ohio 45433

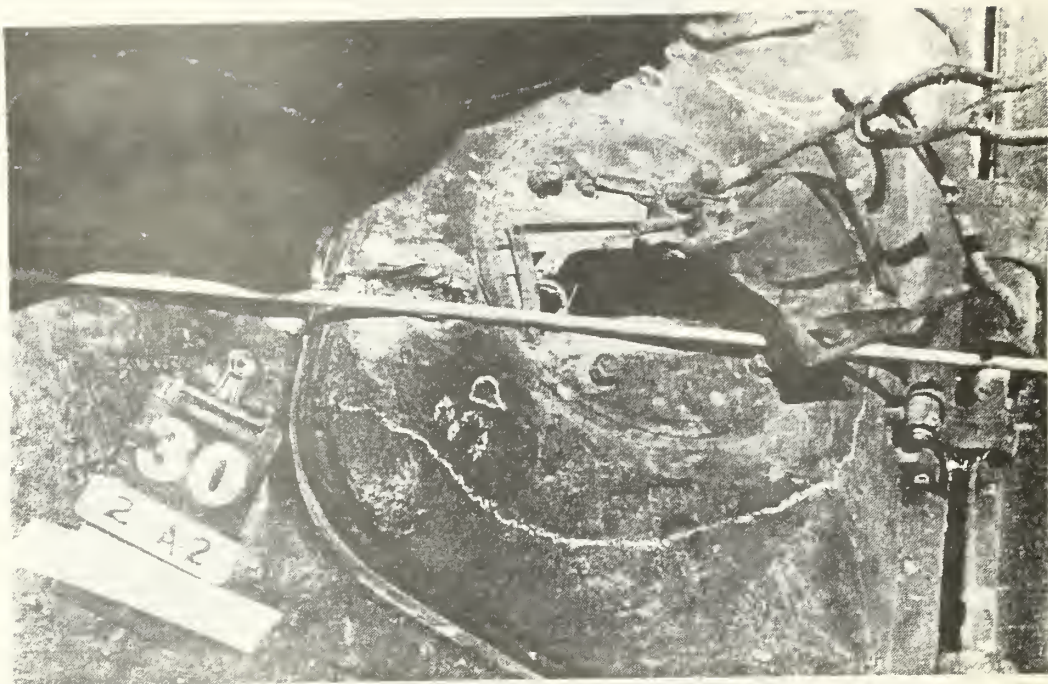
Figure 15. -- TARGET 2, IMPACT 30

a. M-100%: based on crew casualties from 4 perforations and cumulative damage to exterior mobility components especially the penetrated hub of right number 3 road wheel (Impact 42) and the driver's periscope (Impact 30) (See Figs. 15 and 16)

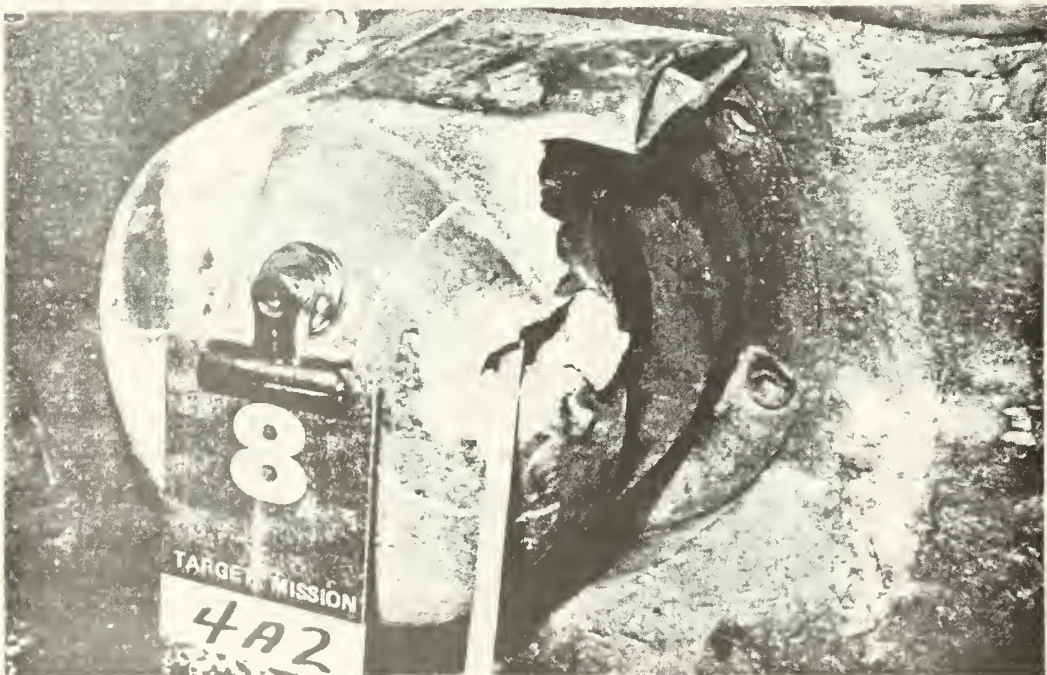
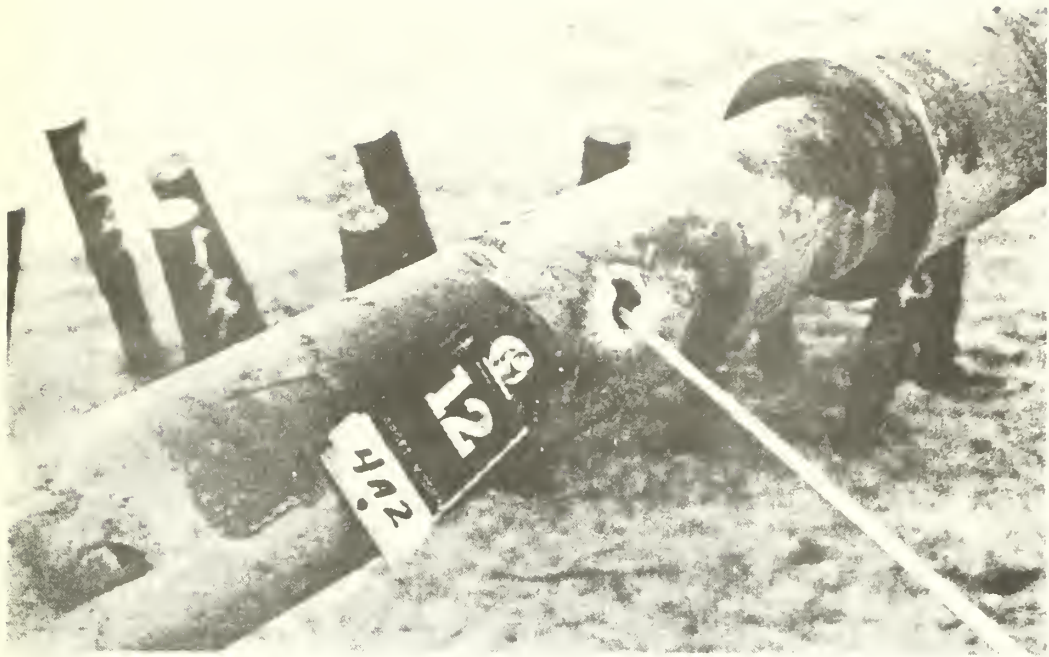
- b. F-70%: based on wounded L (Impact 5), damaged range-finder (Impact 8), and perforated gun tube (Impact 12) (See Figs. 17, 18, and 19).

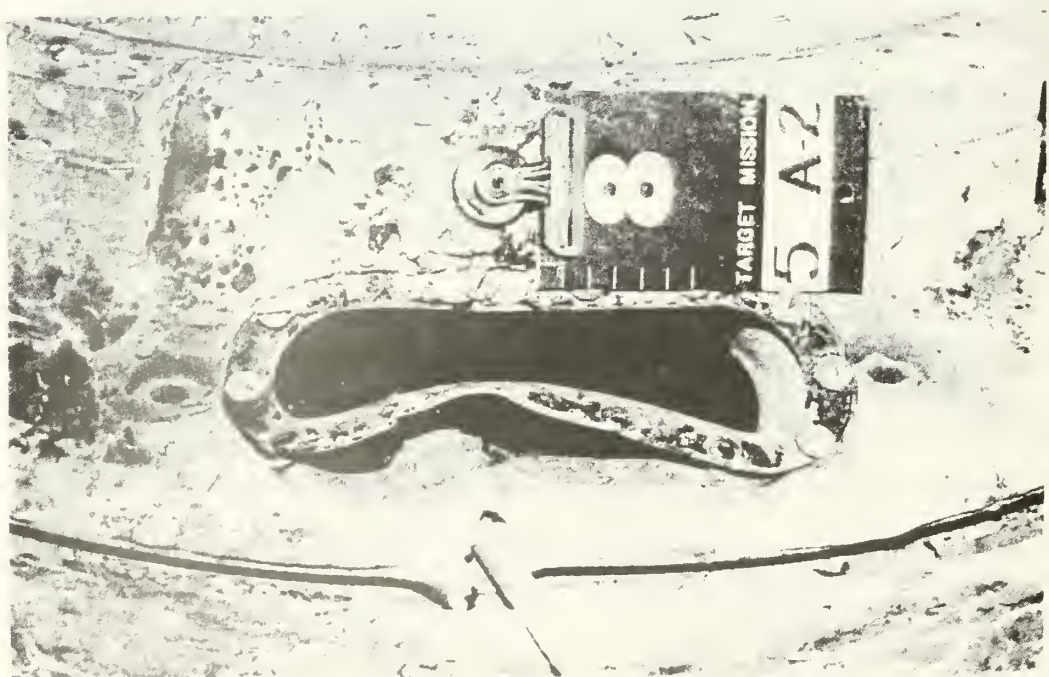
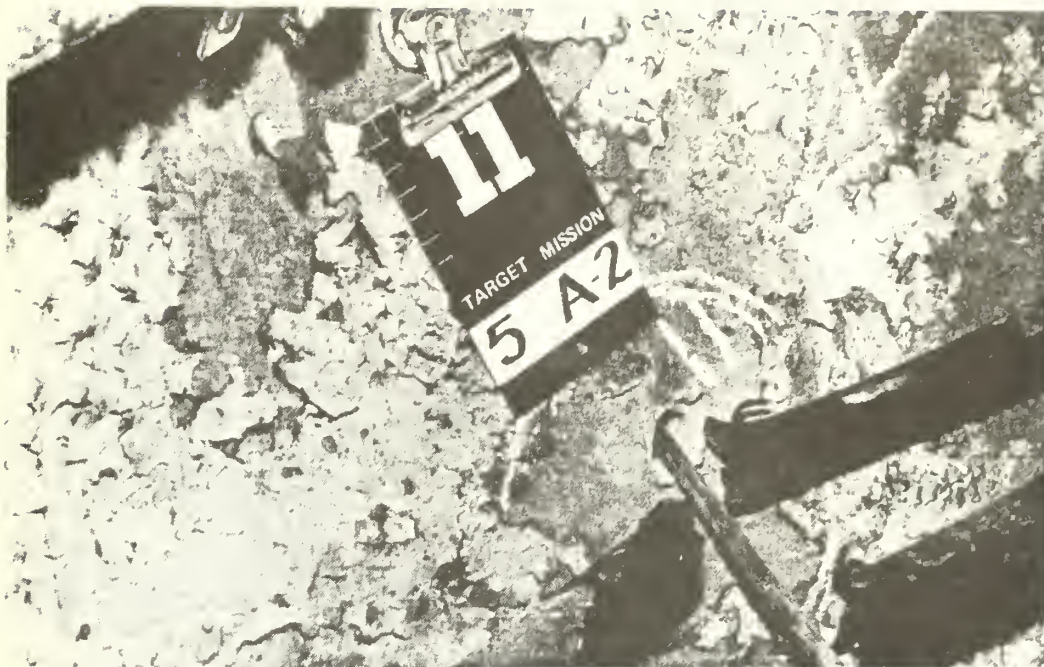
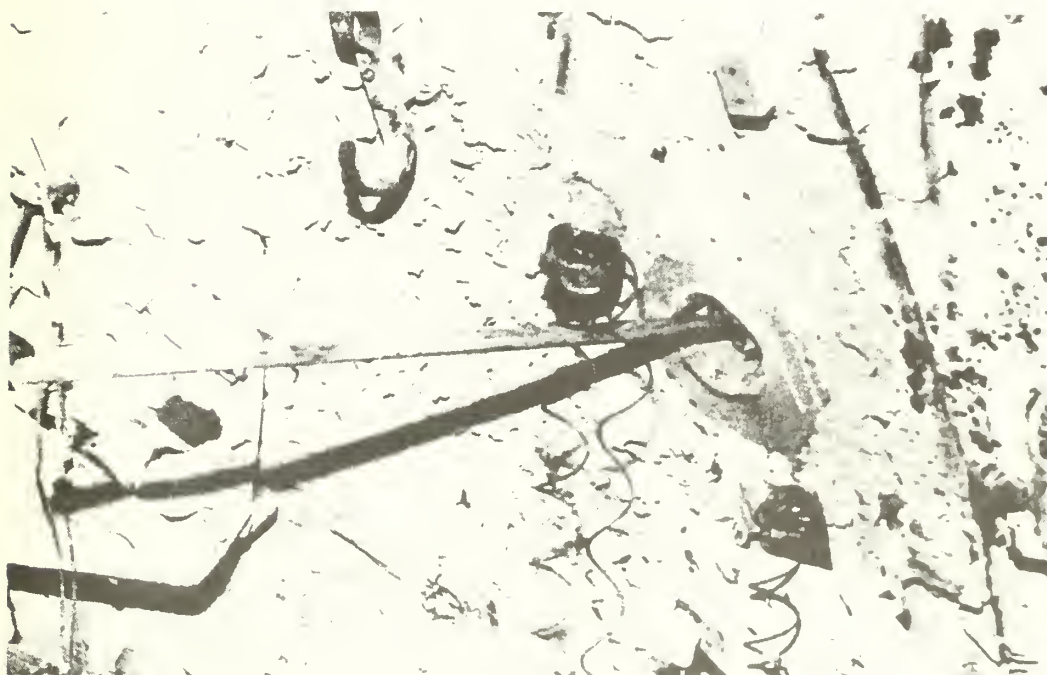
2. Kill Assessment: K-Kill, resulting from the following impacts.
 - a. Perforations - 9
 - b. Significant and Insignificant Damage resulted from 67 additional impacts, but all such damage was overridden in importance by the catastrophic internal effects of the 9 perforations.

3. Rationale for Kill Assessment: Every one of the 4 perforations into the turret and 5 perforations into the hull could have ignited either fuel or ammunition. By 10.3 minutes from the time it was first fired on, tank 5 was observed burning. Several minutes earlier the tank was observed smoking and the CDAT concludes that a fuel (or oil) fire was ignited and rapidly developed into catastrophic explosions of stowed ammunition and ignition of fuel in main cells. The crew casualties assessed from perforations 5, 6, 8, and 11 would have prevented the crew from controlling any internal fire. (See Figures 22, 23, 24 and 25.)

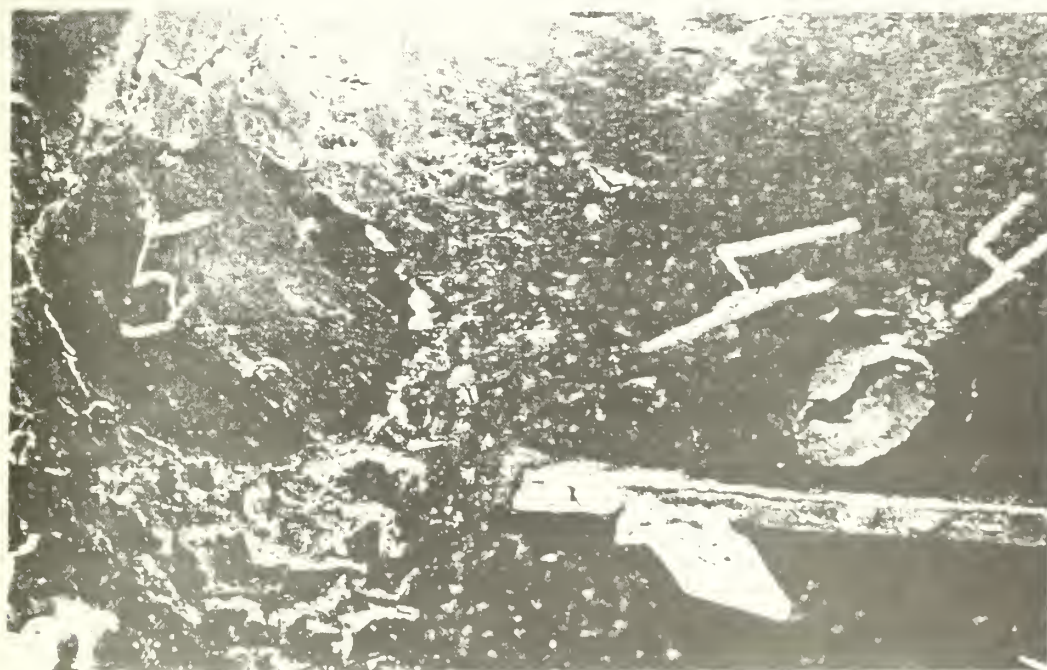
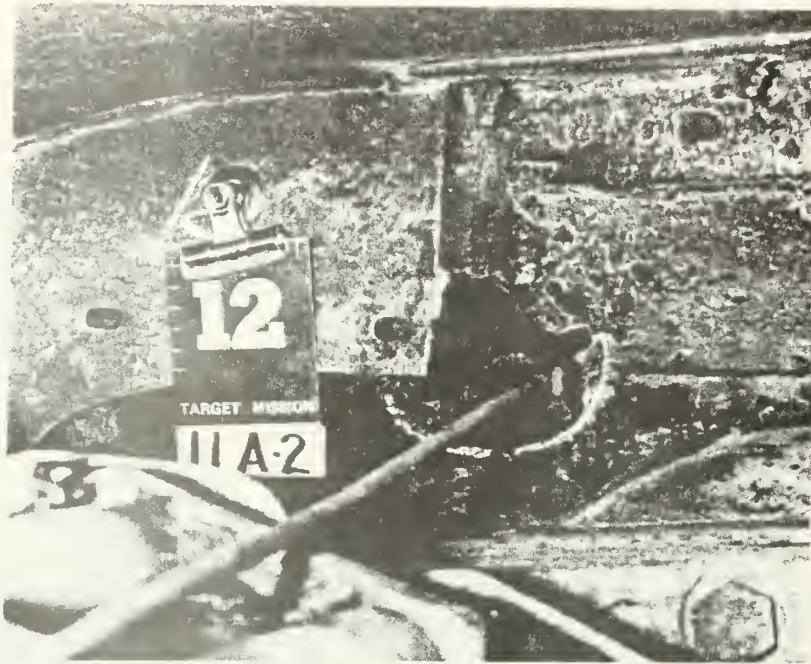
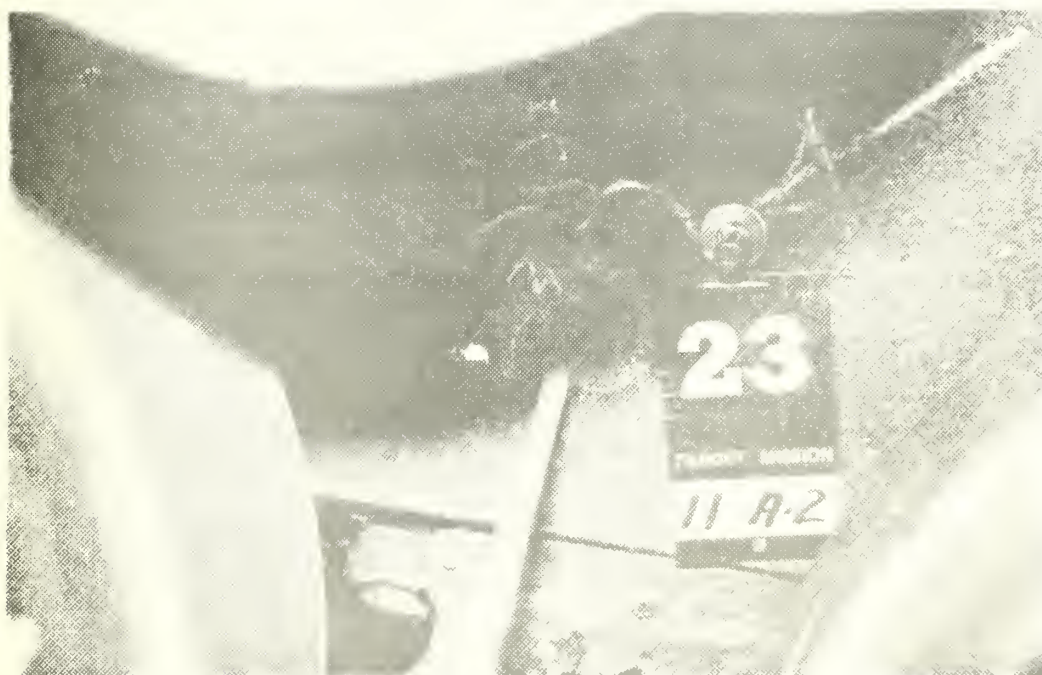
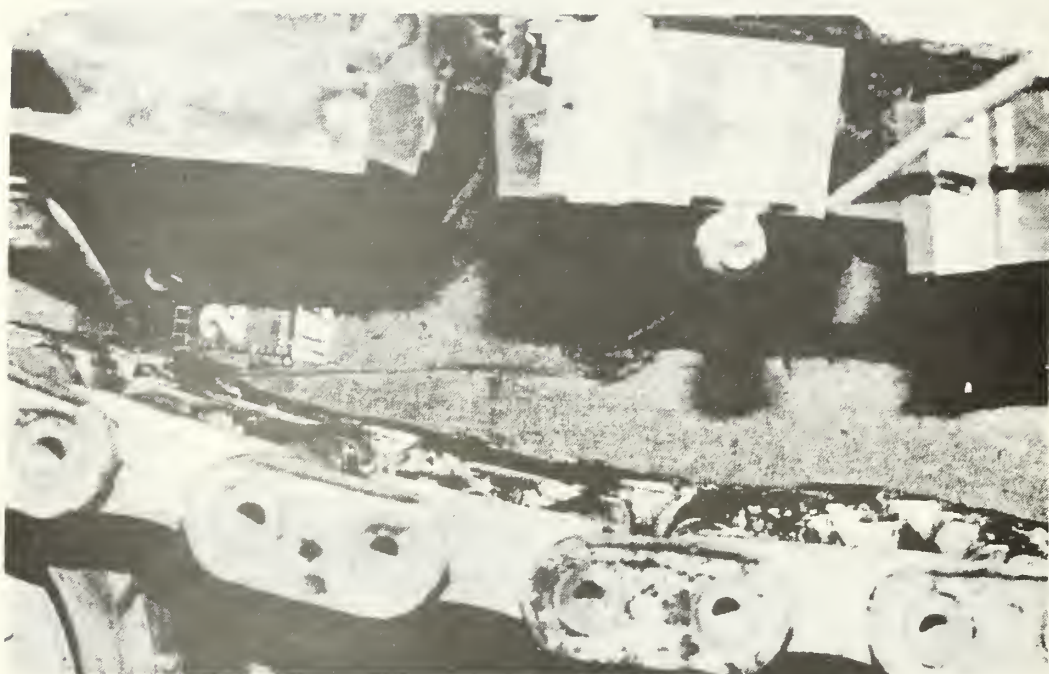
2. Kill Assessment: K-Kill resulting from the following observed effects.
 - a. Perforations - 7
 - b. Significant and Insignificant Damage resulting from 27 additional impacts. All such damage, however, was overridden in importance by the catastrophic internal effects of the 7 perforations.

3. Rationale for Kill Assessment: Three perforations (3, 4, and 27; see Figs. 32, 33, and 38) were achieved into the fighting compartment, two of which had the capability of causing crew casualties and/or igniting stowed ammunition. Four perforations (12, 13, 18, and 23; see Figs. 34, 35, 36, and 37) were achieved into the engine compartment, one of which penetrated into the right fuel tank. The CDAT assessed an immediate K-Kill resulting largely from perforation 23 through the right fuel tank, which in combination with the casualty-producing perforations (impacts 3 and 4), other perforations, and external impacts resulted in an uncontrollable fuel fire.

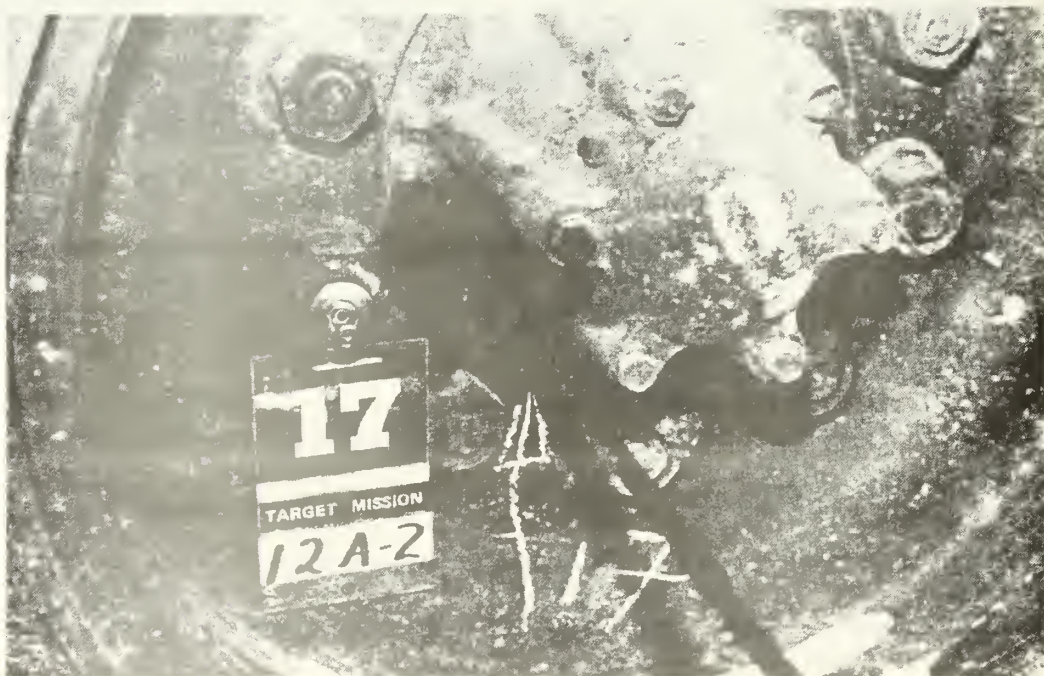
- b. F-100%: based on perforations 5, 6, 7, and 27, which killed or wounded all five crew members, and impacts 20 and 23, which jammed the turret making it impossible to traverse.

- c. See Figs. 39, 40 and 41 for photographs illustrating the weapon effects and damage from impacts 7 (gunner casualty), 17 (road wheel hub penetrated), and 20 (turret jammed).

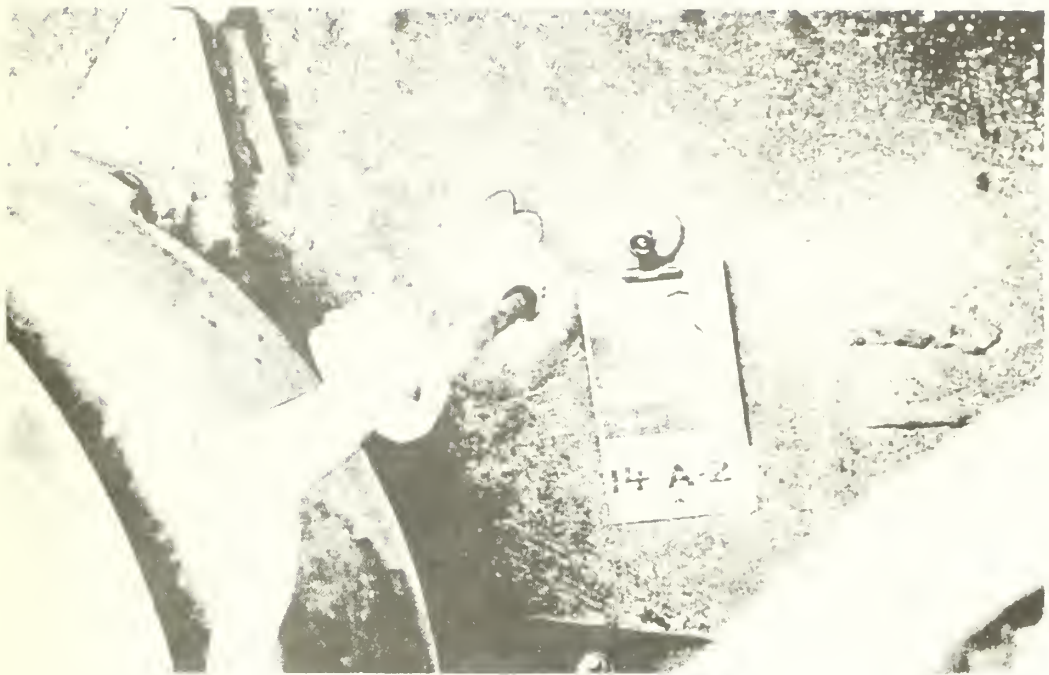
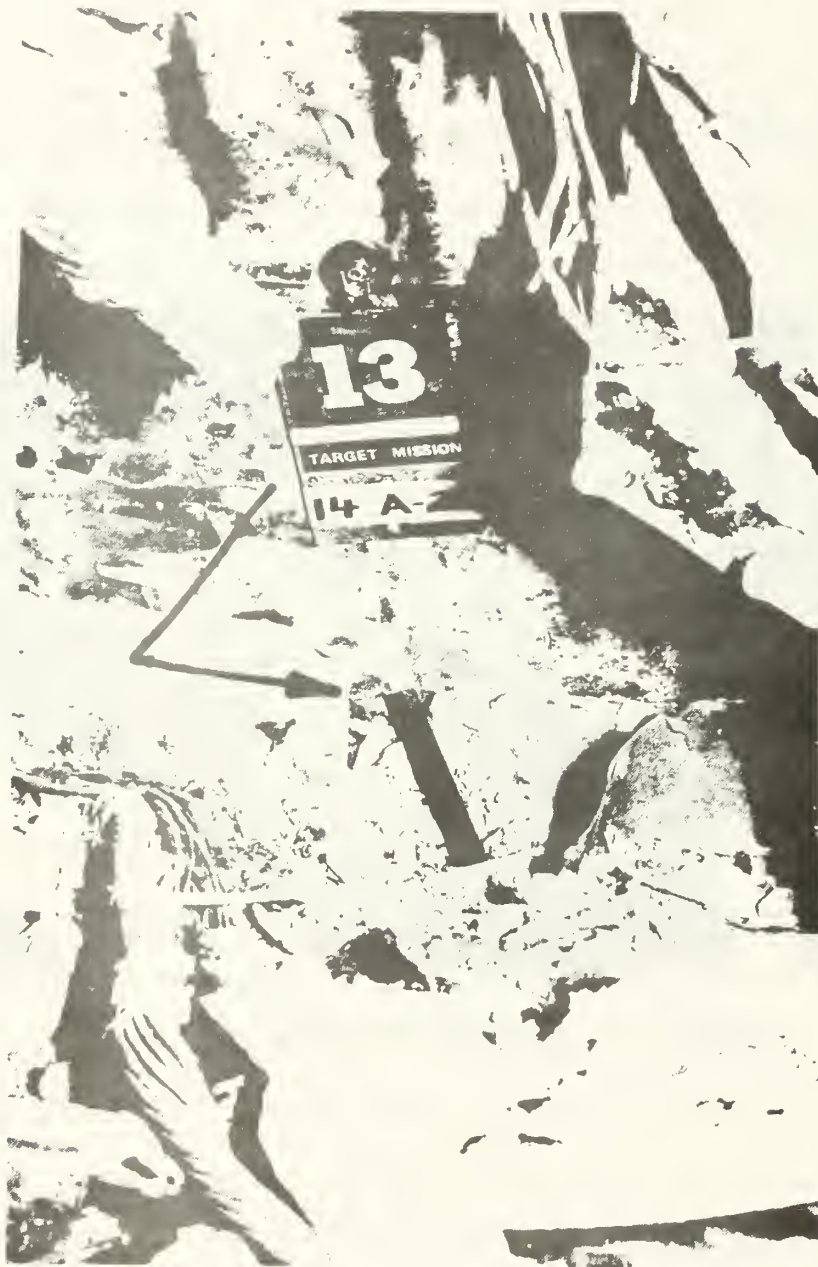
2. Kill Assessment: K-Kill resulting from the following observed effects.
 - a. Perforations - 6
 - b. Significant and Insignificant Damage resulting from 8 additional impacts. All such damage, however, was overridden in importance by the catastrophic effects of the 6 perforations.

3. Rationale for Kill Assessment: The CDAT assessed the damage to tank 14 as an immediate catastrophic kill based on the observed internal ammunition explosion during the first firing pass against it. Perforation number 13, which had the location, azimuth, and residual energy to contact and (ignite) stowed ammunition was the killing agent (see Figs. 42, 43).

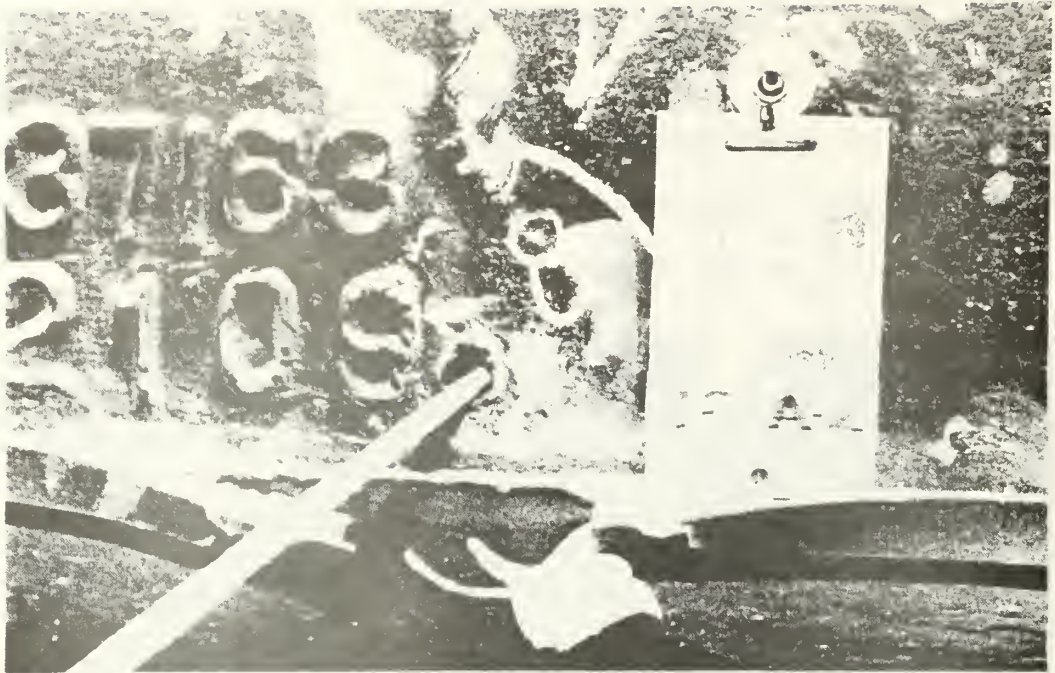
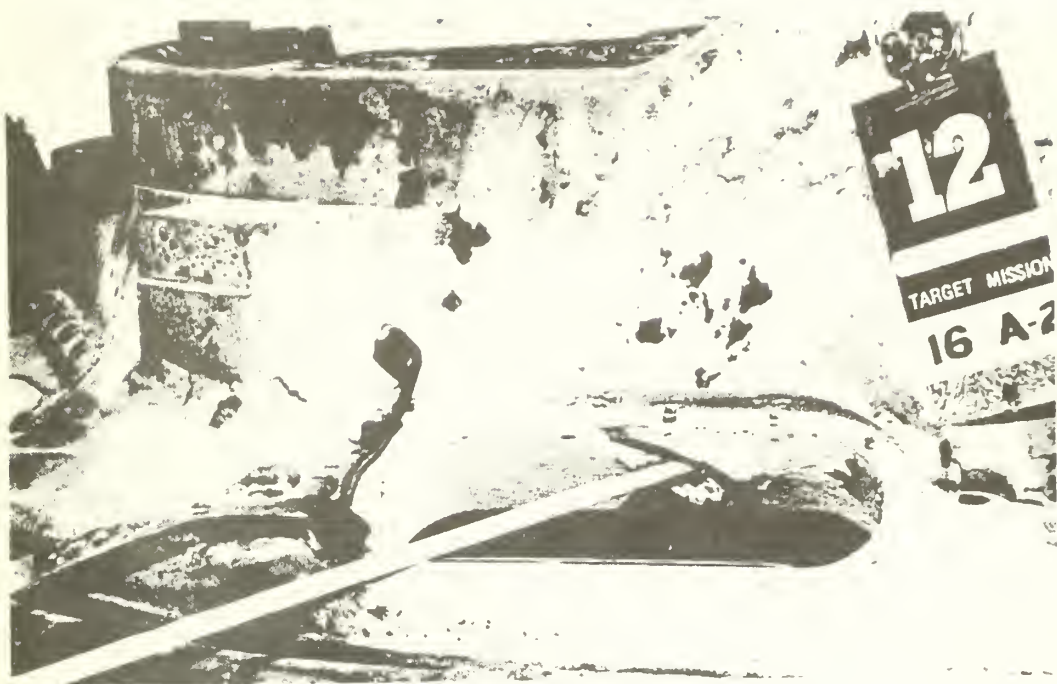
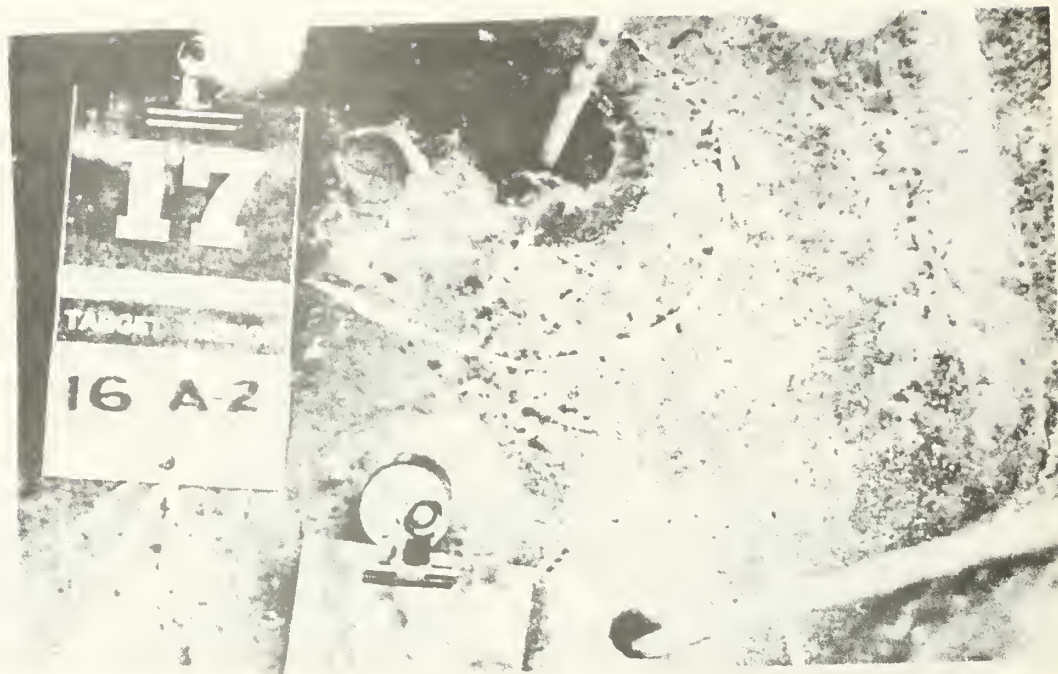
2. Kill Assessment: K-Kill resulting from the following observed effects.
 - a. Perforations - 8
 - b. Significant and Insignificant Damage resulting from 22 additional impacts. All such damage, however, was overridden in importance by the catastrophic effects of the 8 perforations.

3. Rationale for Kill Assessment: Four projectiles (impacts 8, 10, 12, 13) perforated the right side of the turret with high probability of causing casualties to tank commander, gunner, and loader. Four projectiles (impacts 5, 7, 18, 20) perforated the engine compartment armor with indeterminate damage but probable ignition of fuel and/or oil in that area. The target began to smoke immediately after the second firing pass against it, and 2.6 minutes later, shortly after the third firing pass, was observed to be burning. The CDAT assessed a K-Kill resulting from the rapid propagation of a fuel fire during and after the second firing pass, which could not be controlled by the crew (see Figs. 45, 46, 47, 48, 49, 50 for impacts 8, 12, 18 and 20, as representative perforations of turret and engine compartment).
